TS440S Repair FAQ

10-29-02 by Mike Freeman KC8QNO

I recently ran into some problems with my Kenwood TS-440S. Here is a list of my problems.

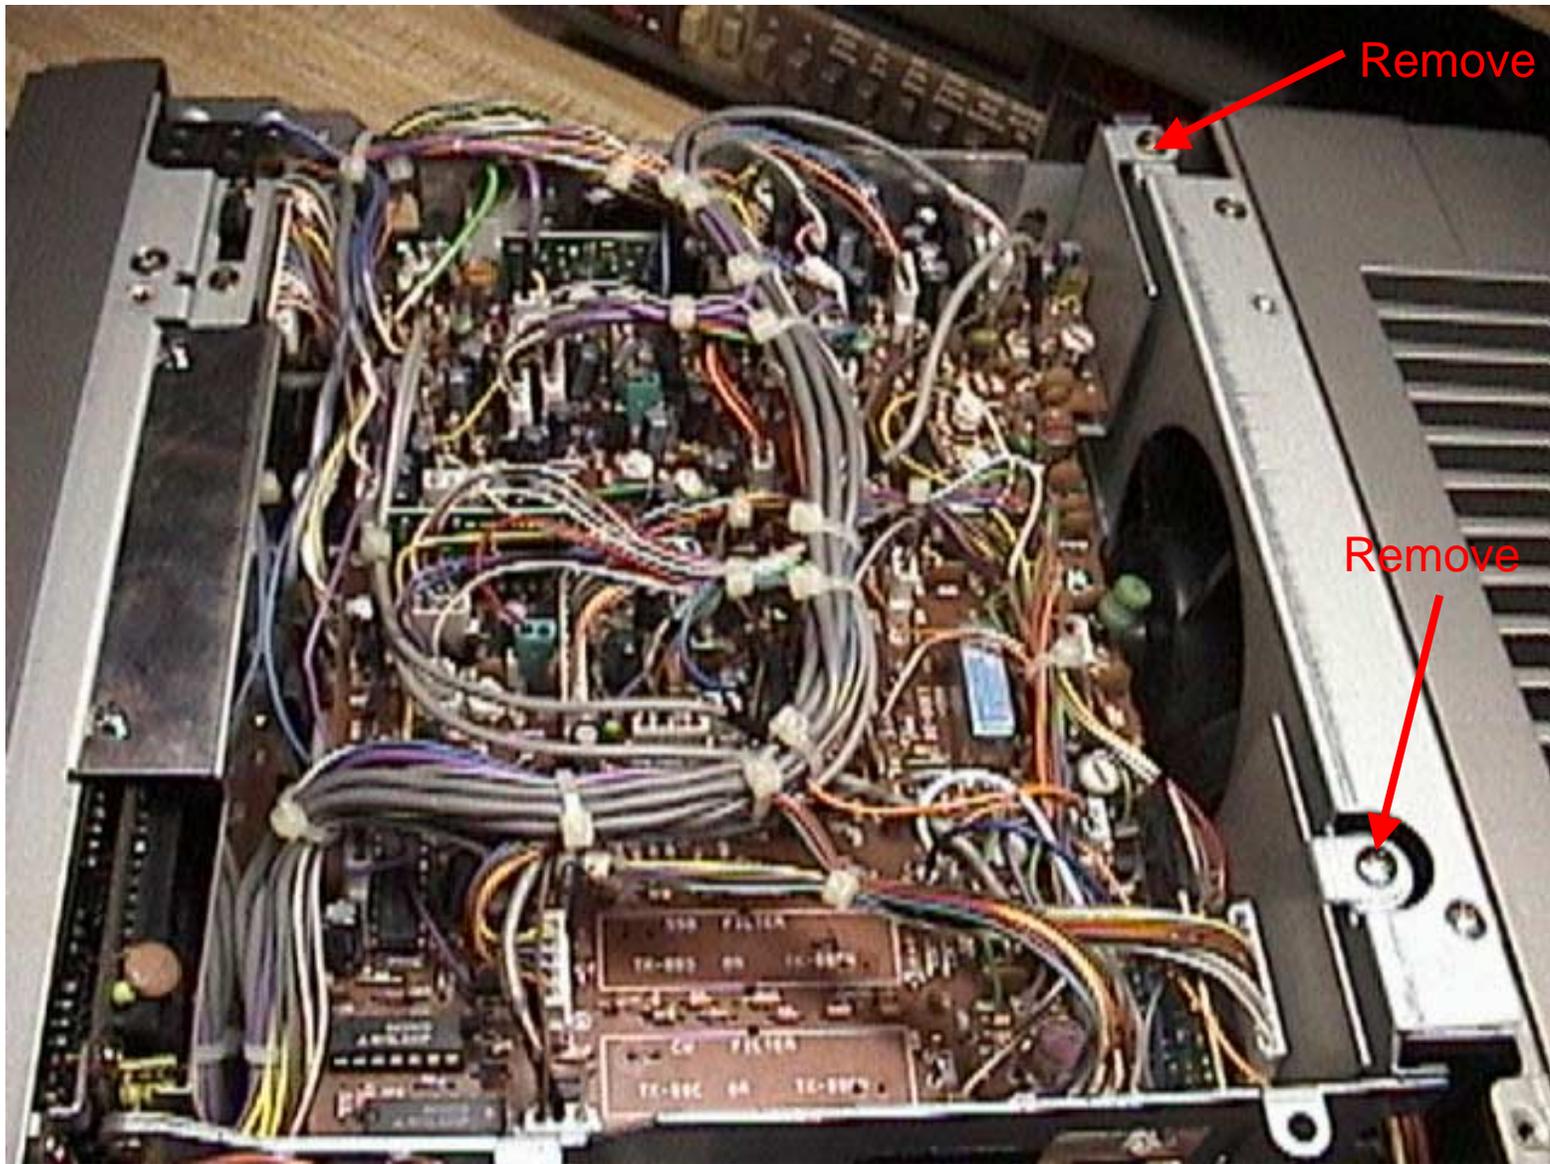
This is the TS-440S with no top cover. You can see the IF Board. Remove the two screws to expose the PLL board underneath.

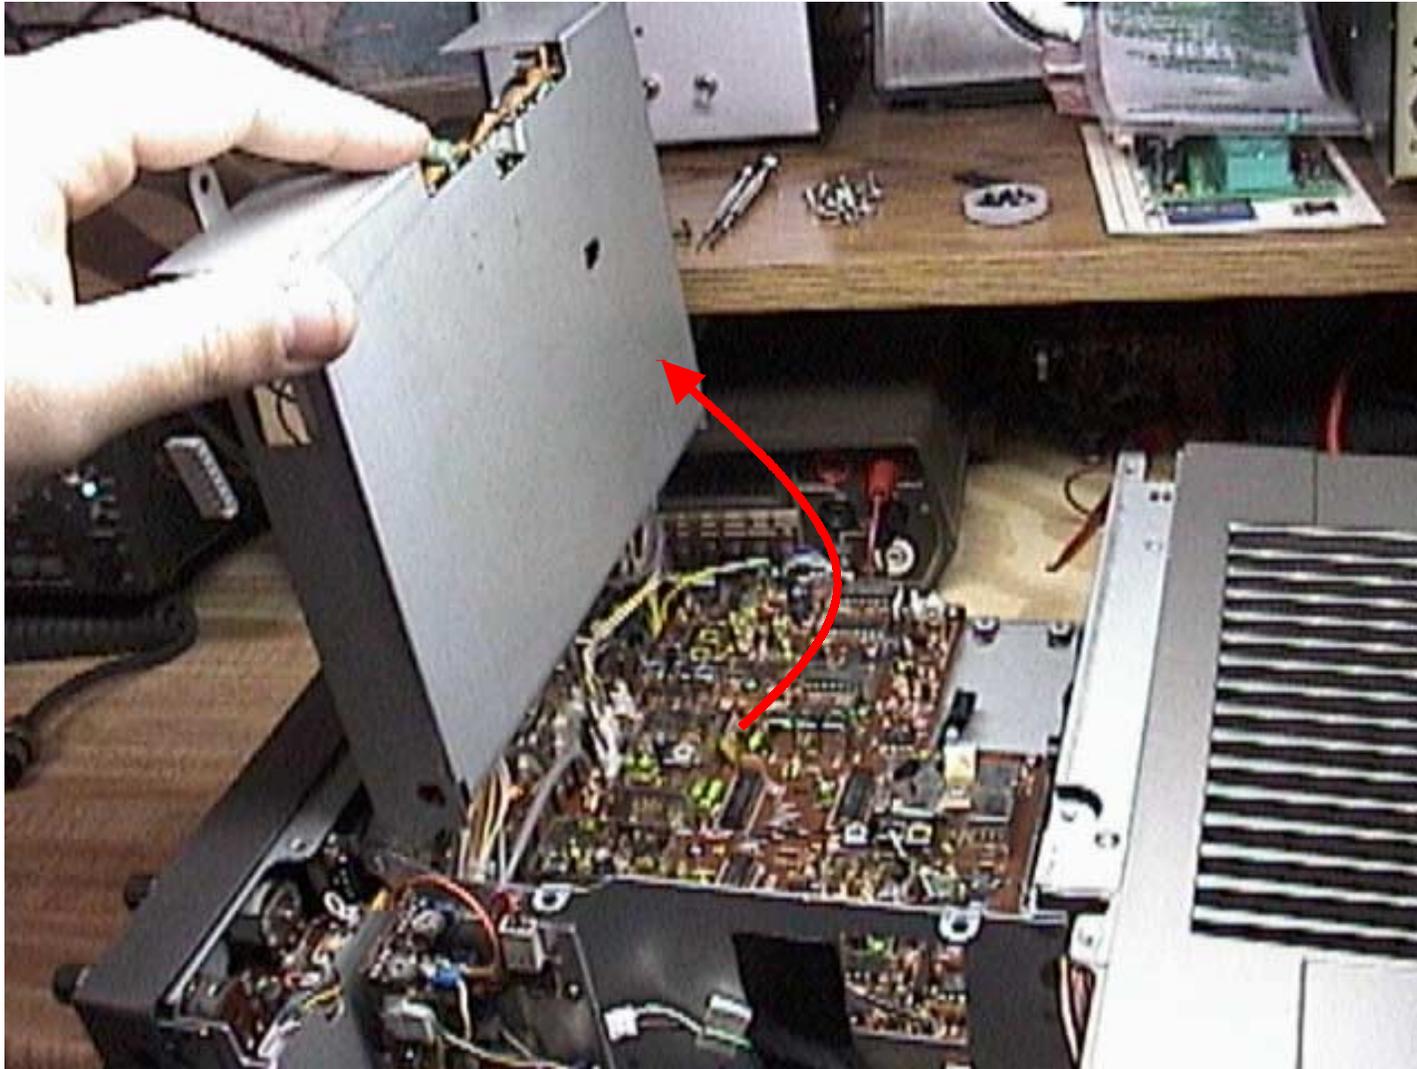
The IF board will swivel up on a hinge exposing the PLL Board. It may be necessary to unplug a few cables on the IF board to get it to lift up.

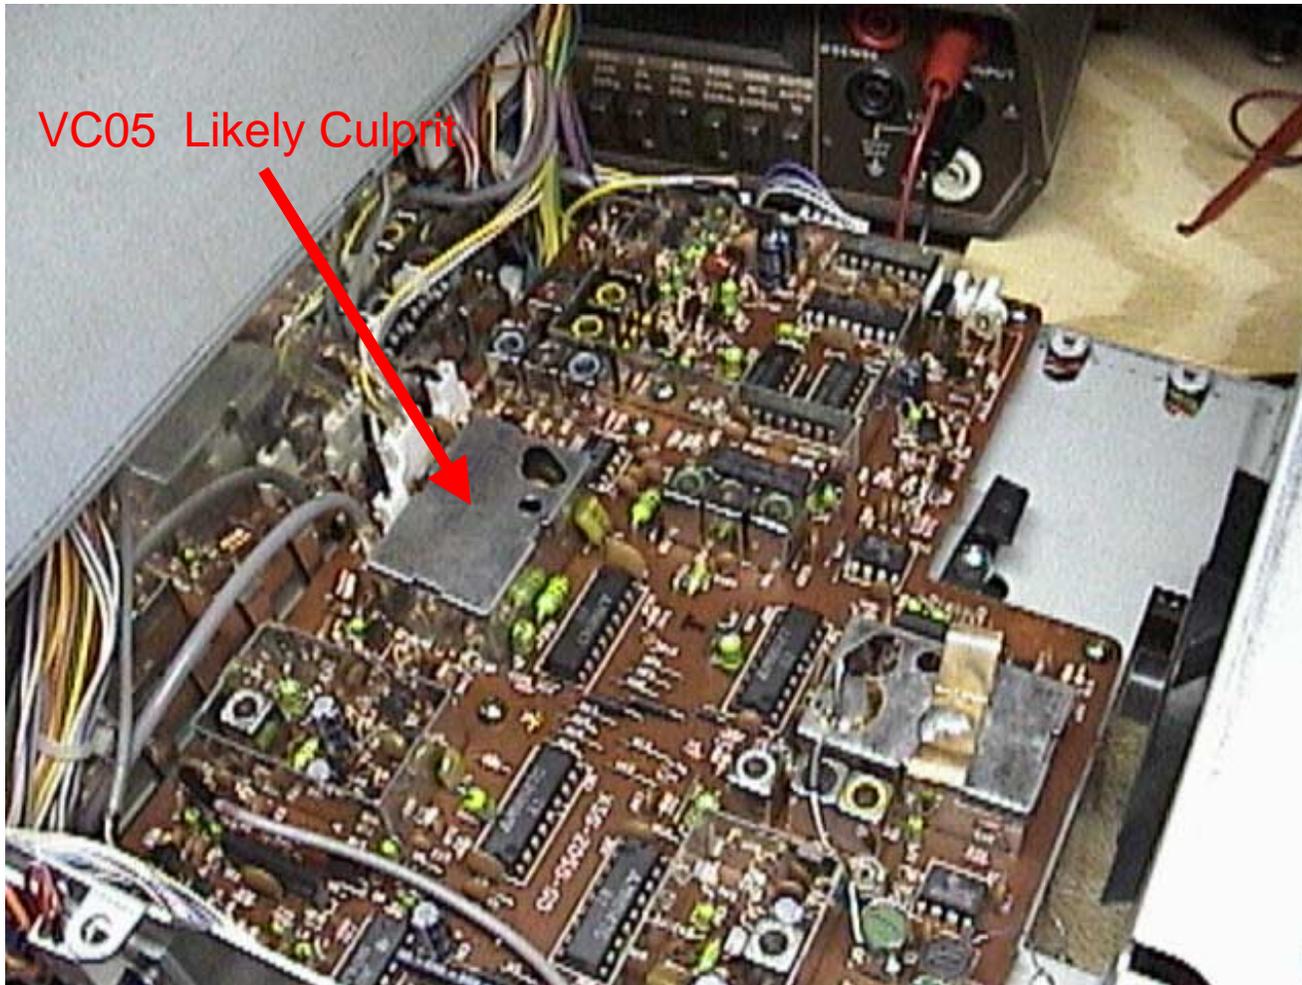
PLL board. Located under the IF board.

VCO5 has a stabilizing compound “glue” to help secure the components during mobile operation. After time this compound can get conductive and cause problems in the RF board and PLL board. If it is brown or shows a few volts when you probe it to ground then its bad.

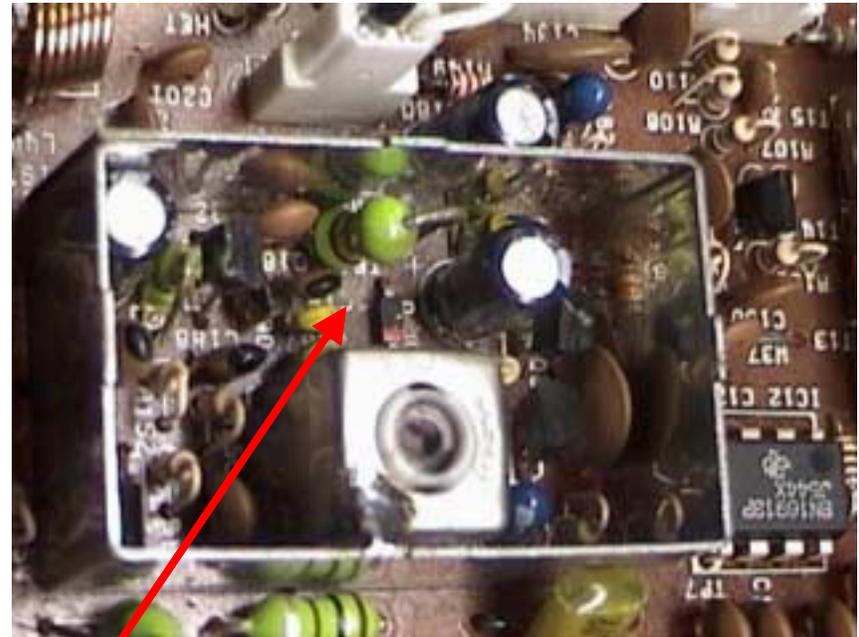
VCO5 on PLL board with top off.

The top easily pops off with a small screwdriver.

The “glue” is located here. I am showing my VCO5 after I removed all the glue. (I forgot to take a pic of it before). I removed it with a pick and tweezers. I had to remove a few components to get the glue all out from the contacts. Make sure you remove it all. You may have to unsolder the metal shield around the VCO to get all the glue out.

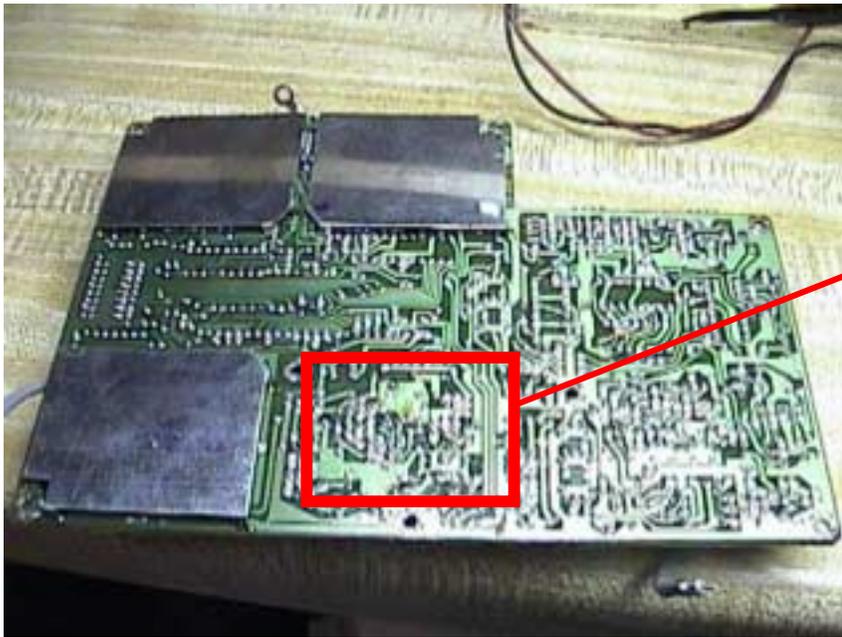
PLL board (solder side)

Now, since you got the PLL out. Flip it over and check for cold solder joints. Check the VCO5 Area (see below). Use lots of light and a magnifier of some sort. A bad solder joint will have a slight ring around it, also it may have some whitish-grey oxide on it. To be safe I re-soldered all points in this area. Make sure you do not get sloppy and solder multiple contacts together.

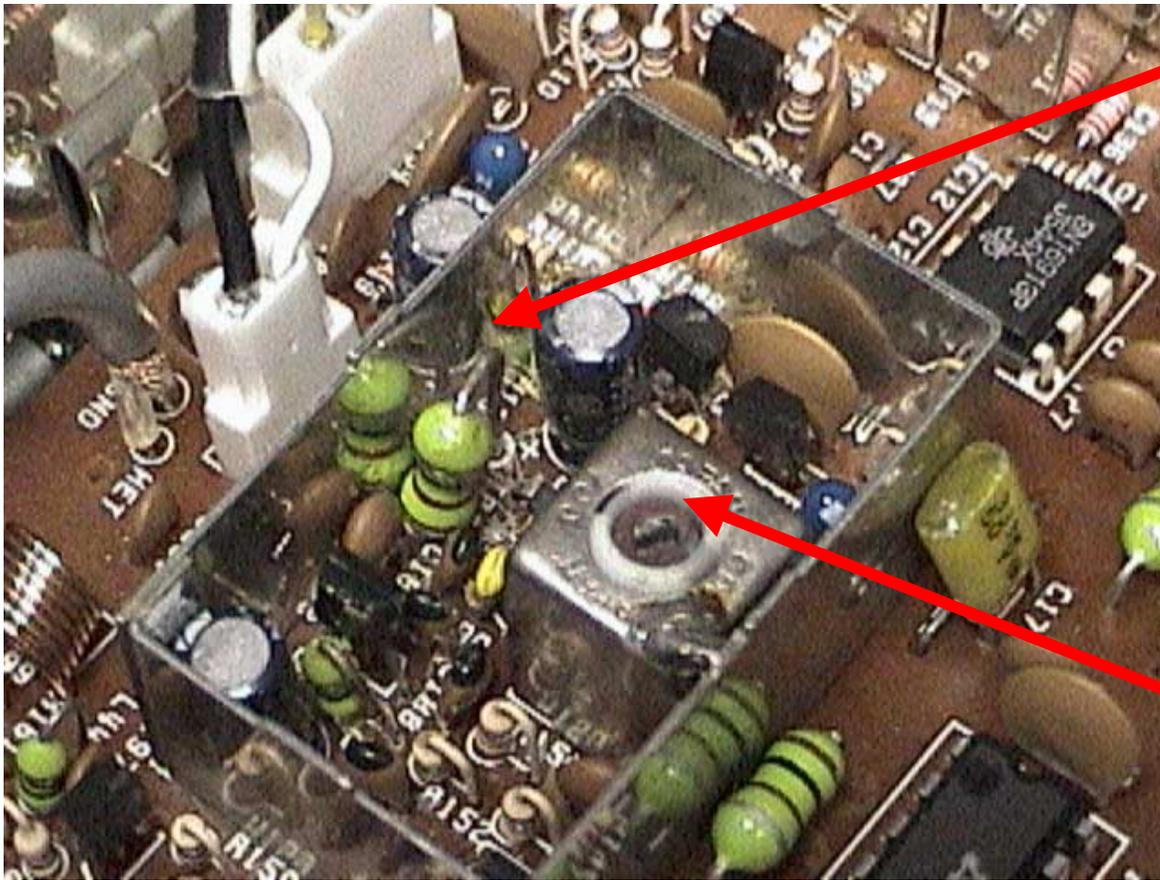
TP11. Exposed end of Inductor. This is where you want to take a voltage reading from. Connect the red lead here, and the black lead to any point on the chassis (ground).

VCO5 on PLL board with glue removed.

Adjust with a small screw driver until you get a reading of 5.00 Volts from TP11.

In order to check VCO5, you need to have all your cables plugged in and the PLL board replaced. Turn on the radio for about 30 minutes to warm up, set it for 14.200Mhz USB. You should get 5.00 Volts on a good DMM. If not, adjust (very slightly) the metal can. Replace VCO cover when done.

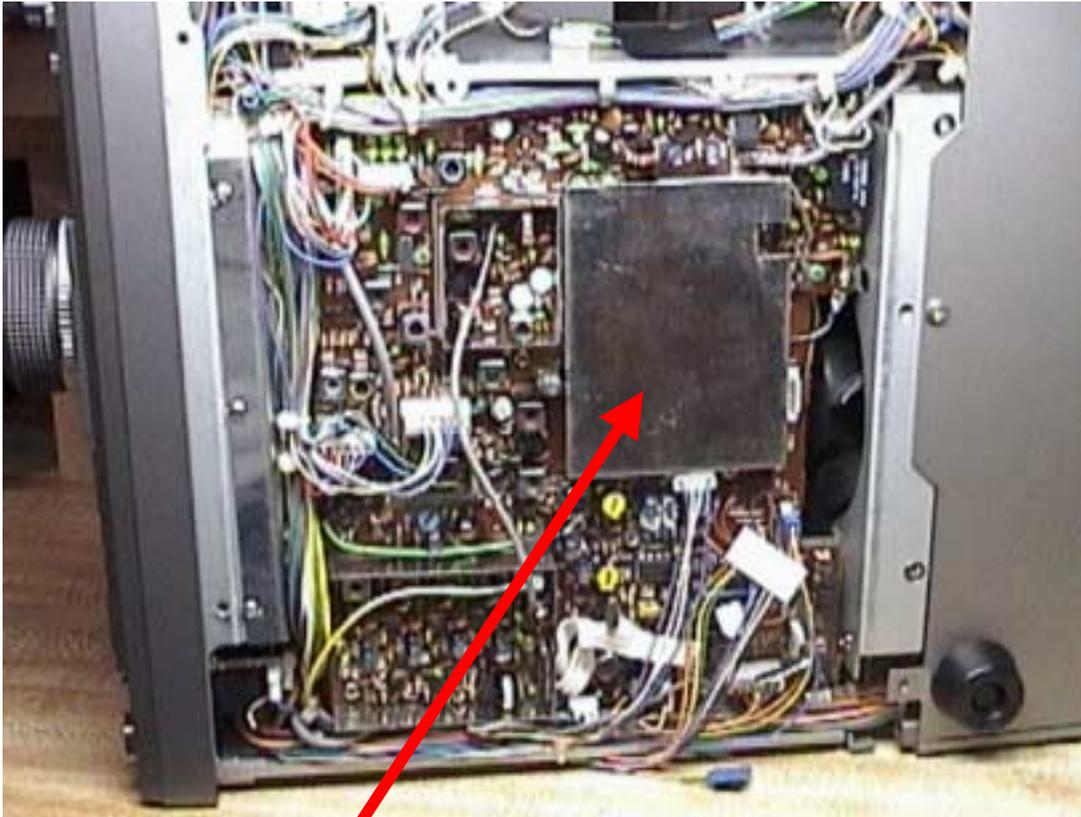
If you still are having problems, flip the rig over and take the bottom cover off. You now are looking at the RF board.

This is the area on the RF board that contains the Band select circuitry. Carefully remove this metal shield to expose the components.

If you are still getting Garbled sound or dots on your display, it may be in this area. (as it was for me). So we are going to check to see if there are any leaky diodes in here. Do not remove the RF board from the TS-440S yet. Leave it in because we are going to check for leaky diodes first. I removed it for reasons explained later on.

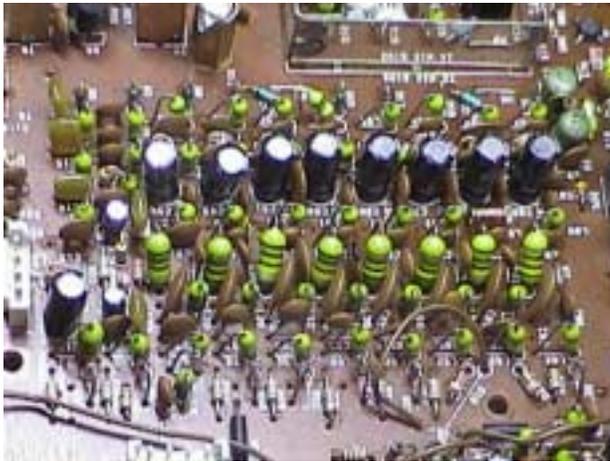
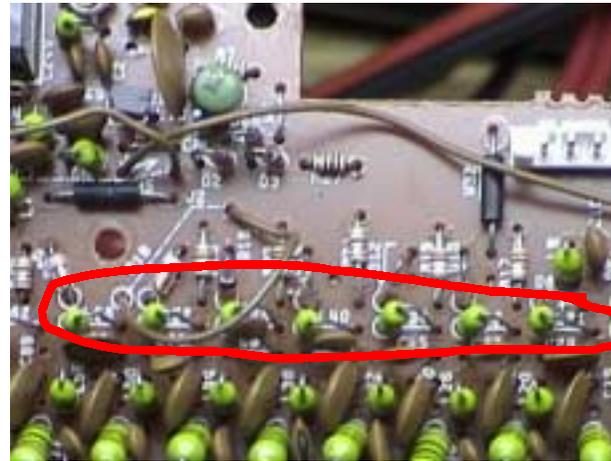
These yellow inductors are your test points.
Follow directions below.

The most common symptom is the PLL unlock. Reset the transceiver by holding in the A=B button as power is turned on. Even if the display only shows decimals, only the (band pass filter) BPF for 14 MHz should be turned on. Using a DC voltmeter, measure the voltage at coils L11, L15, L21, L28, L34, L40, L46, L52, L58, and L62. Only coil L52 should measure 8 Vdc. The other coils should read 0 Vdc. If one reads 0.5 - 8 Vdc, replace the two diodes in that BPF circuit.

Replace diodes with 1S2588 ,1SS91S or 1S1587 (I used these)

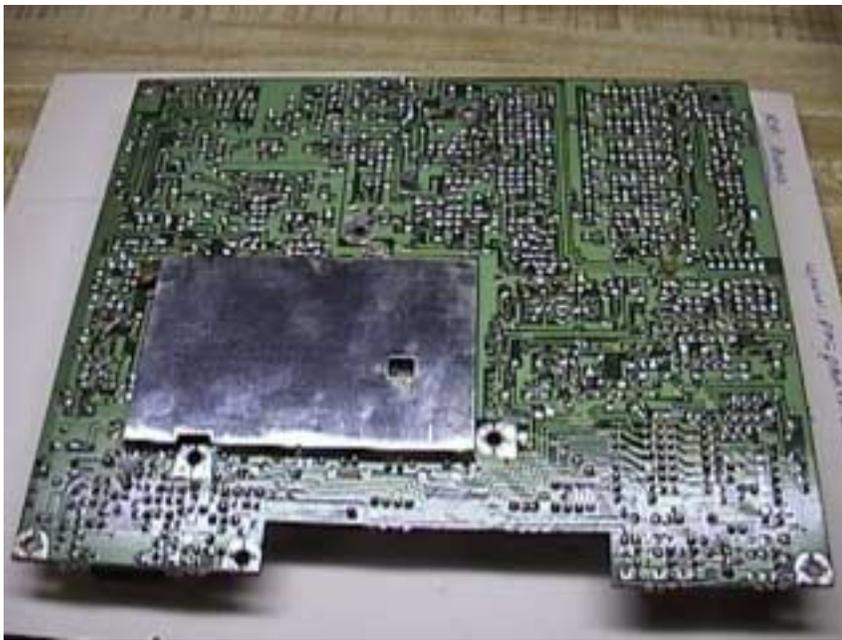
RF board removed (solder side) with shield.

If you find a bad diode remove the RF board carefully (like you did with the PLL board). Notice the metal shield? Well you guessed it, you must carefully remove it by unsoldering it from the RF board.

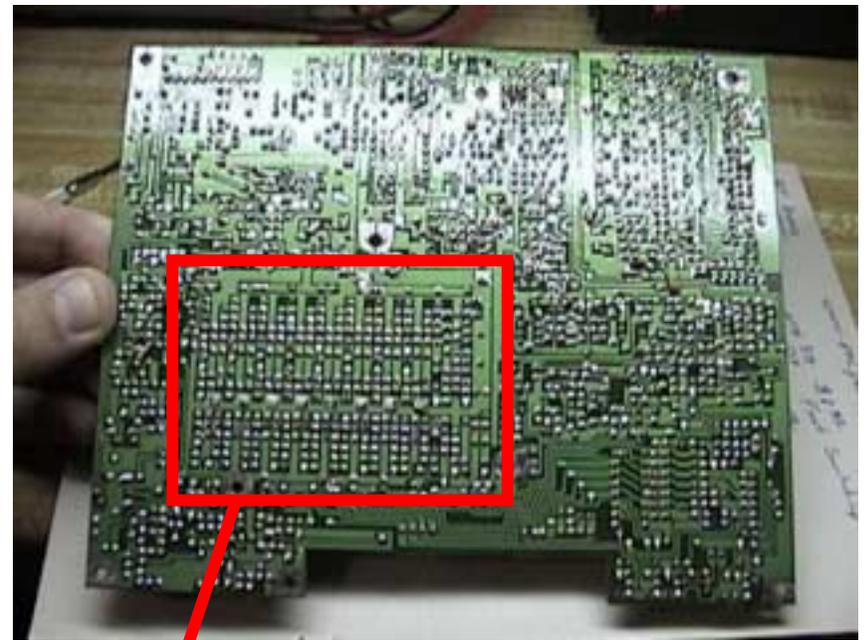
RF board removed (solder side) no shield.

After the shield is removed, replace your diodes. Also, very important. Check for bad solder joints here. I found several and repair as necessary in the entire area. This is a very likely area if you have dots on your display only on one frequency. Its because of broken solder joints.

Again, do not get sloppy with the solder in here! Very Bad!

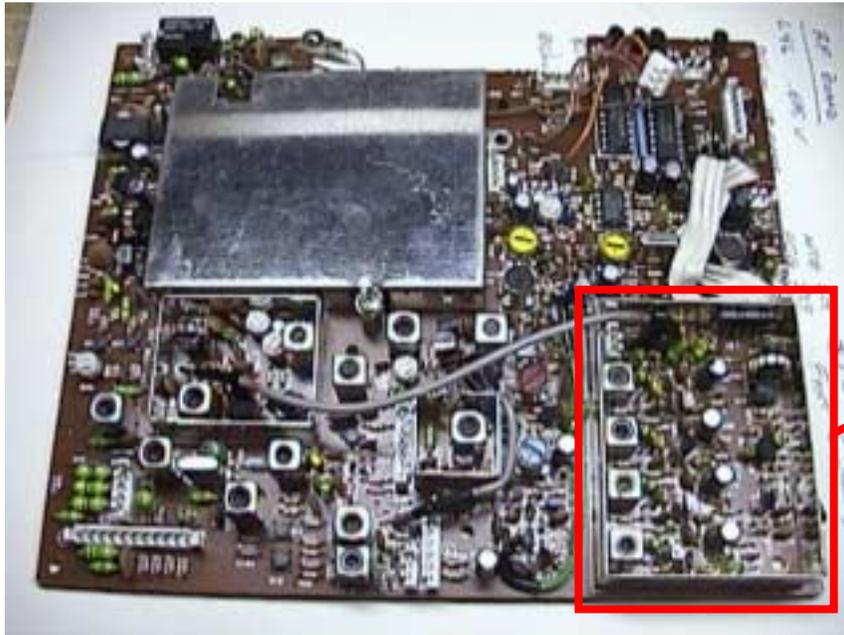
RF board.

Remember the RF board (bottom of the Rig? Don't remove yours, leave it in. But look at it. See the 4 cans to the right?

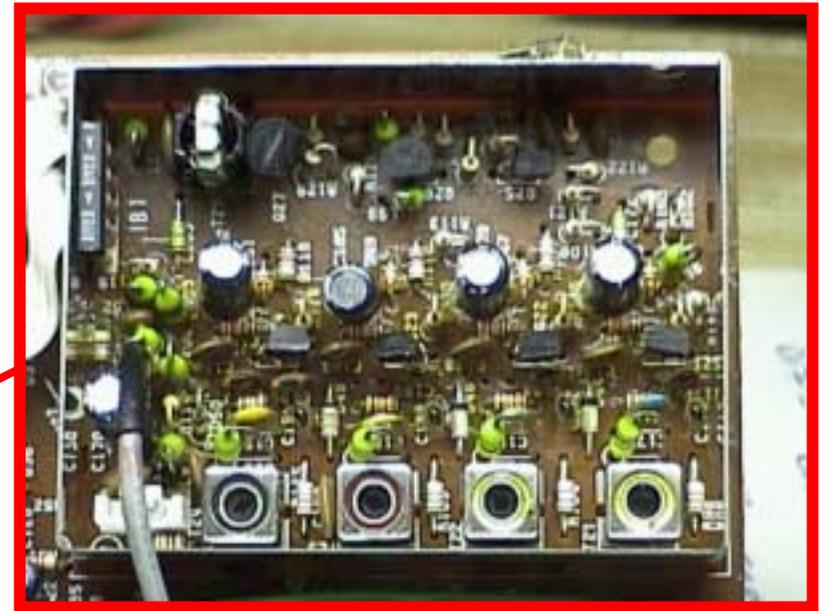
VCO cans.

We are now interested in this area. These are the cans that adjust your VCO1's (I believe the adjust the PLL locking for VCO1). From left to right they are:

T24,T23,T22,T21

29.9999 Mhz, adj T21 for 2.5 volts on TP10

21.9999 Mhz, adj T22 for 2.5 volts on TP10

14.4999 Mhz (this is where the svc manual was in error, it says 14.9999), adj T23 for 2.5 volts

7.4999 Mhz, adj T24 for 2.5v

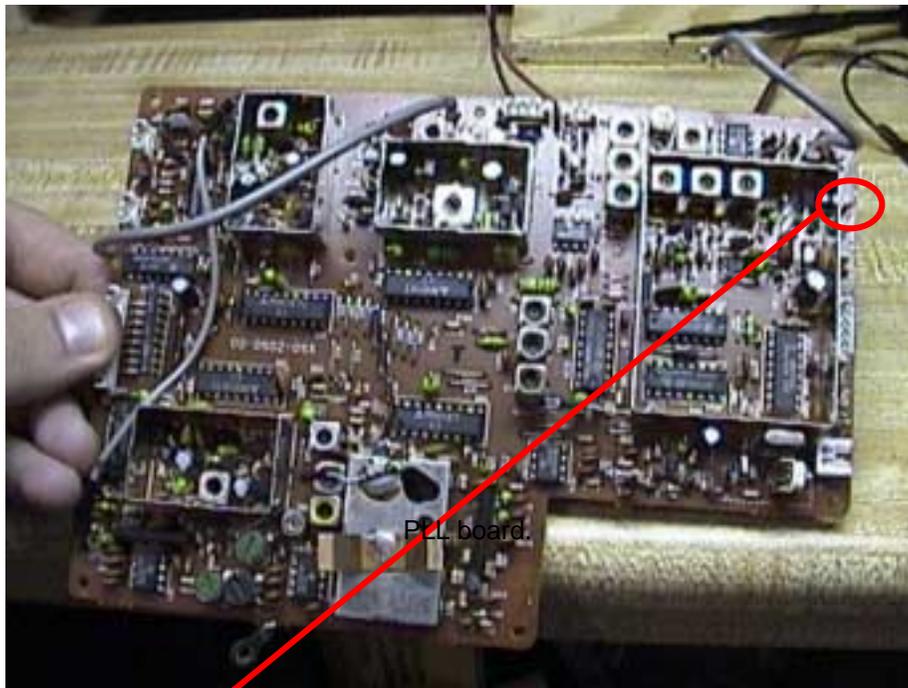
R138

Measure at R138, TP10 on the PLL unit, with DC VOM

Also, remember the PLL board? Again, leave yours in. Do not remove it. You want to find R138. Your voltage test point is the exposed lead of this resistor. You should be able to see it with the IF board secured down. Just place your rig on its side and look for this resistor on the edge.

Check at 22.0000, 14.5000, 7.5000 and 30.0 kHz, for TP10 to read around 5.3-5.5 volts, not critical as long as it isn't above 6.2 volts.
